10/518463

Stripping results in the SEZ spin etcher with various H<sub>2</sub>SiF<sub>6</sub> concentrations.

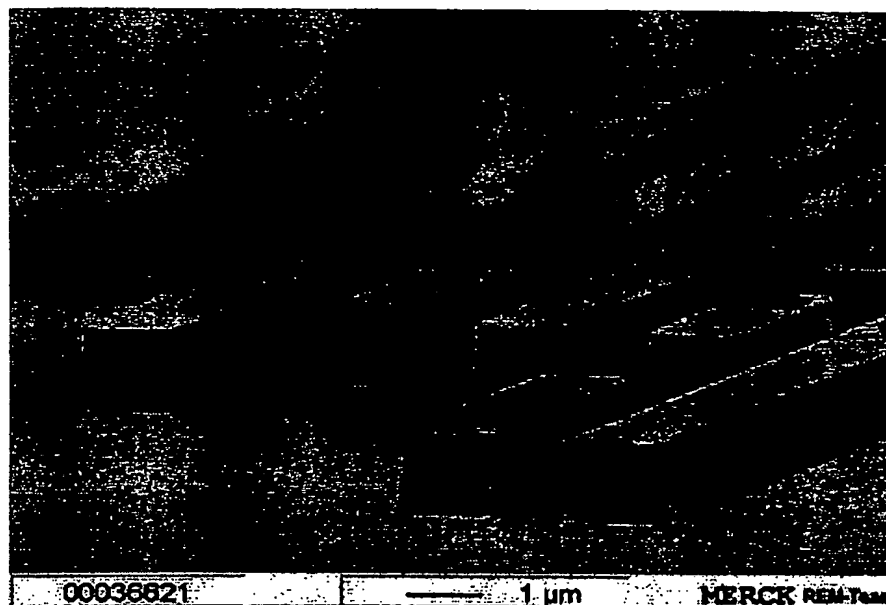
**Fig. 10**

Stripping results in a Mattson AWP tank processor with various  $\text{H}_2\text{SiF}_6$  concentrations.

After stripping with 100 ppm of  $\text{H}_2\text{SiF}_6$

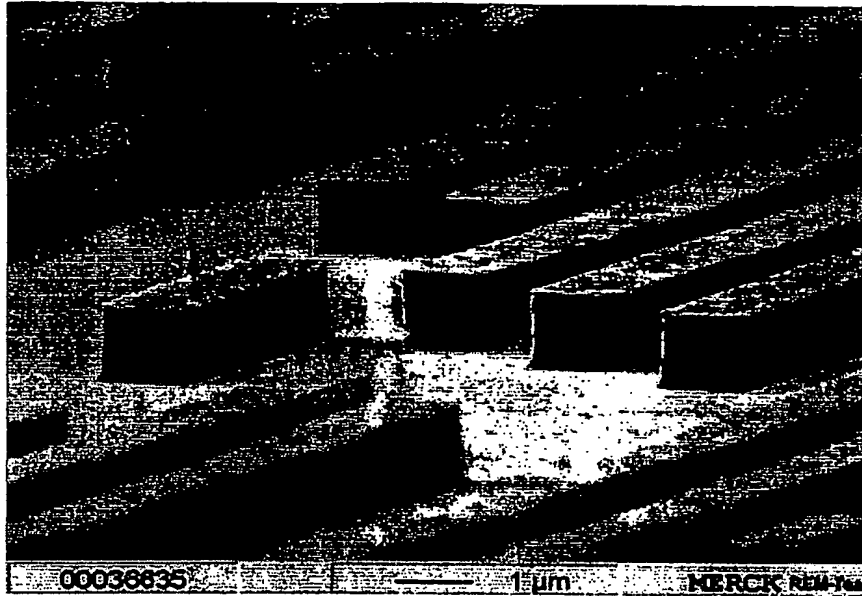
**Fig. 11**  
After stripping with 600 ppm of  $\text{H}_2\text{SiF}_6$
